Historical Changes in Erosion and Sedimentation along Driftless Area Channels and Floodplains

Jim Knox Department of Geography University of Wisconsin Madison, WI 53706-1491

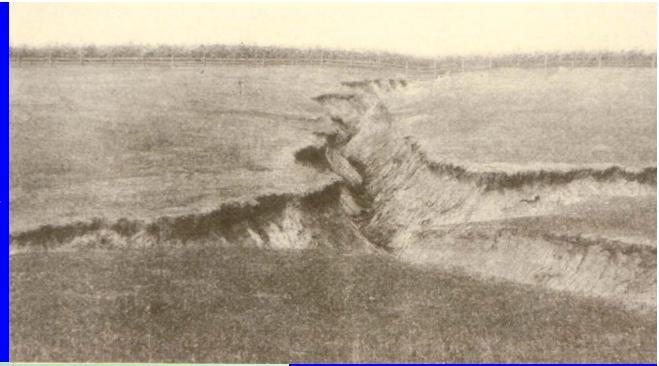
Jo Daviess County, Illinois, Gully Below Ridge-Top Corn Field; Described as Typical of Early 1910s Tributary Drainages in Jo Daviess County. (Trowbridge and Shaw ,1916).

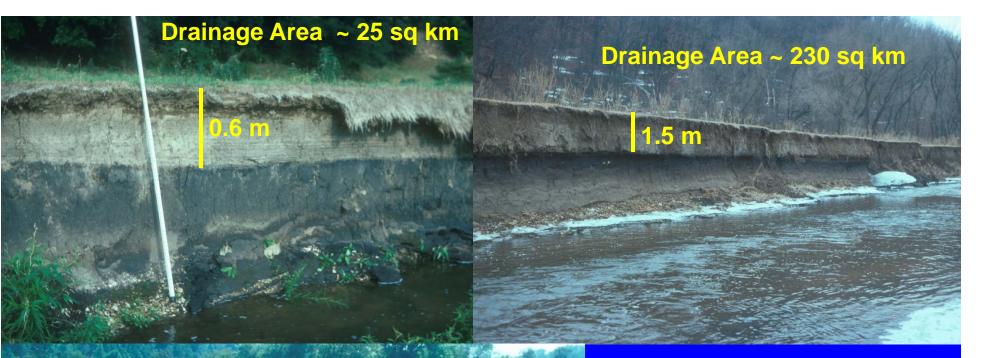
Ground Surface c. 1830 Ground Surface c. 2005

Sheet, Gully & Rill Erosion

Historical Soil Erosion in Upland Fields Since *c.* 1840

Soybean Field near Platteville, Southwest Wisconsin
